The main school building is single storey, timber framed construction with thin block cladding battened onto the timber frame. The building has a timber floor supported by concrete stumps and a metal sheeting roof supported by open web steel roof trusses. It was indicated that the building is approximately 60 years old.

Main Building Scope (Western Wall)

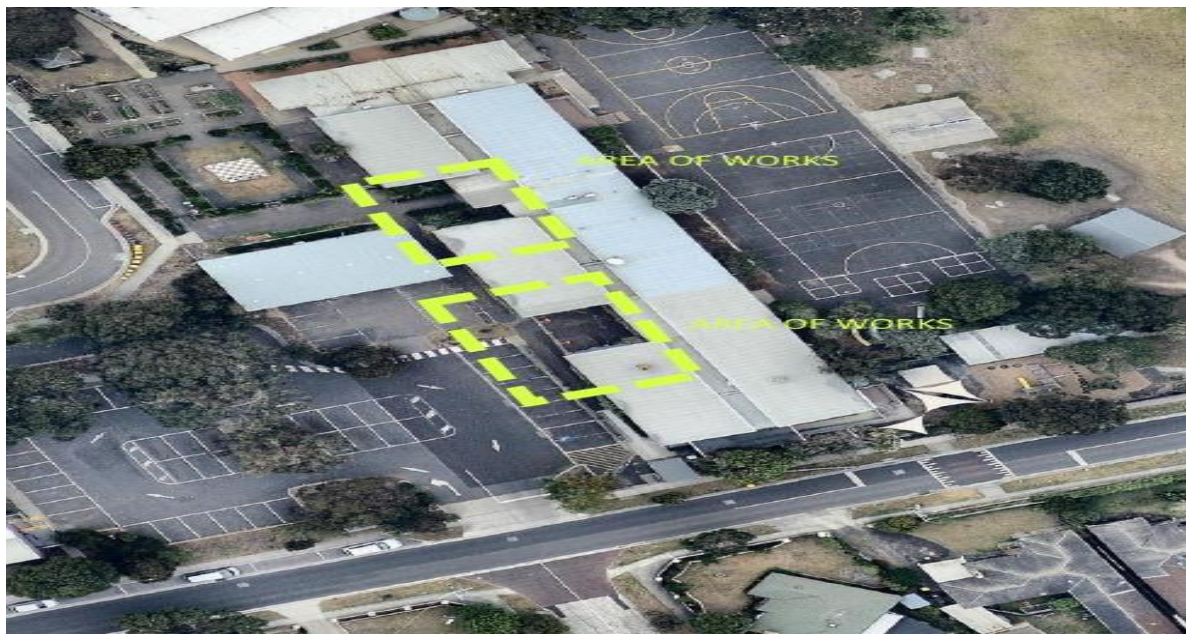
*Edit**from Patrick 25 Jan – the highlighted sections on the image for the Scope of Works are an indication only. Please read below for more detail.*

There is extensive termite damage that has caused structural failure to predominantly the western wall of the main building (LTC Building, Pre-School room 27 and (Male Toilets and female toilets on the SAMS)

- Asbestos removal to western wall of main building where cladding is failing
- Termite treatment program prior to works commencing:

- Demolish existing rotten windows, frames and mullions
- Demolish joists & flooring where rotten
- Demolish existing framing & batons
- Demolish existing blockwork façade
- Demolish and replace all flashing and guttering where required
- Install new colour bond cladding façade
- Install new window frames and windows
- Replace floor boards
- Underpinning and stumping as required
- New external gutters and drainage
- Replace veranda beams

- Demolish & replace existing window frames & mullions
- Demolish & replace termite damaged load bearing walls, studs and battening
- Demolish and replace external façade where necessary
